TECHNICAL BULLETIN NO. 20100709

July 29, 2010

SUBJECT **Communication Patch for Garmin 72H GPS Receiver**

PRODUCT **Field Scout meters that can be geo-referenced**

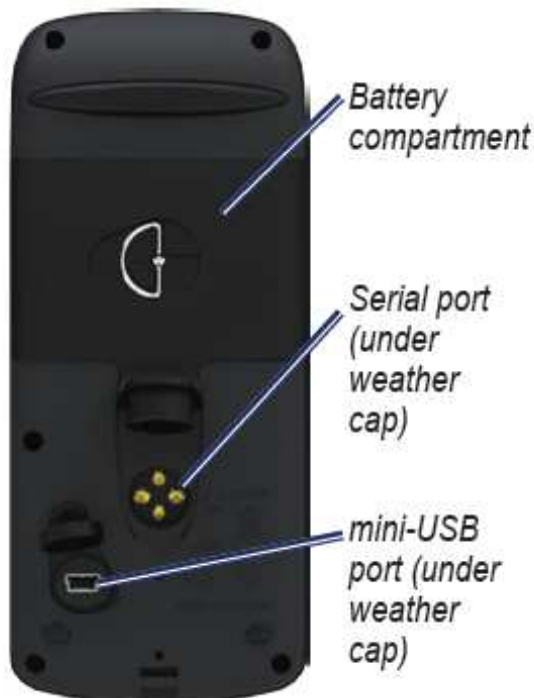
To install the upgrade, you will need a cable with a regular-and mini-USB jack. This cable is commonly used with digital cameras and other electronic devices but is not included with the Garmin 72H. The port for this cable is beneath the smaller flap on the back of the Garmin 72H (see below).

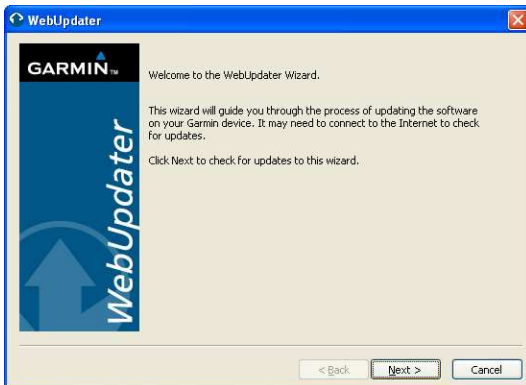
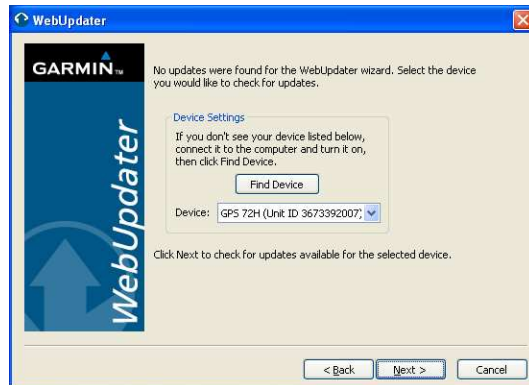
3. Click the **Next** button on the first screen to activate the WebUpdater Wizard. The program should then recognize that it is connected to a model 72H and whether there are any software updates to install. If your meter is already running the latest version, you will get a message that says there are no updates to install (see below).
