TECHNICAL BULLETIN NO. 20100709

July 29, 2010

SUBJECT **Communication Patch for Garmin 72H GPS Receiver**

PRODUCT **Field Scout meters that can be geo-referenced**

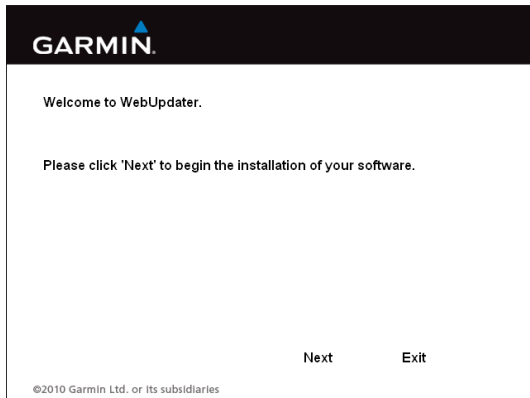
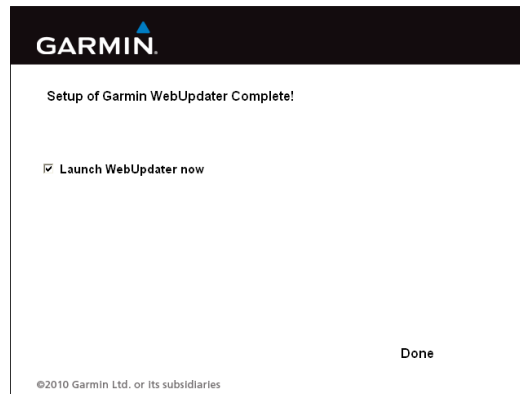
Launch the Updater and follow the screen prompts to install the software.

2. Install Garmin WebUpdater. This executable program can be downloaded to your PC from the following link:
